Automated U-Bolt Inspection System

Matt Huffman, Chris Wade, Jesse Gruber, Nick Scarpitti

Mechanical and Manufacturing Engineering Department, Miami University, Oxford, Ohio, 45056

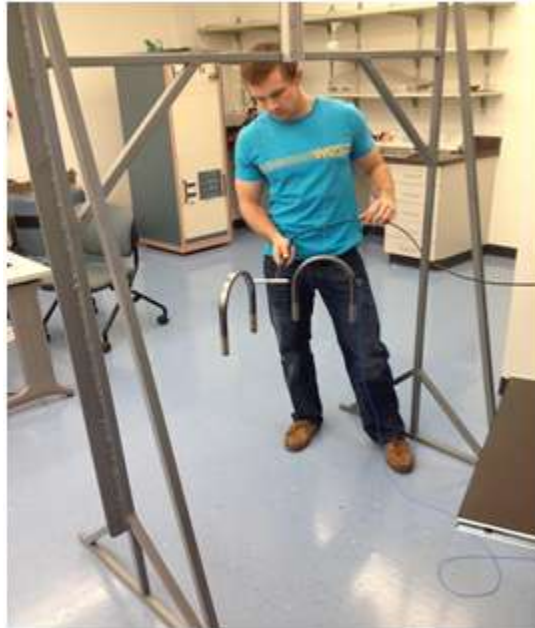
Figure 1. The resonant frequency test setup.

The impact hammer returned data on the impact force to the computer and the accelerometer measured the acceleration caused by the wave generated by the impact. Data was input through Labview SignalExpress. The data was converted and input into MATLAB where a Fast Fourier Transform was performed to examine the frequency response. Three good bolts and three bad bolts were each tested three times to ensure consistent data. Below is the MATLAB code used to perform the FFT, which was created by Dr. Singh [9].

The first step in the design process was to perform experimentation and analysis on the several viable testing methods available for crack detection. After extensive research and discussion, the possible options were reduced to camera, conventional ultrasonic inspection and vibration inspection. Vibration inspection testing was completed by suspending both normal and cracked U-bolts from a test frame. An accelerometer was fixed on one leg of the bolt and the other side was struck with an impact hammer as shown in Fig. 1.

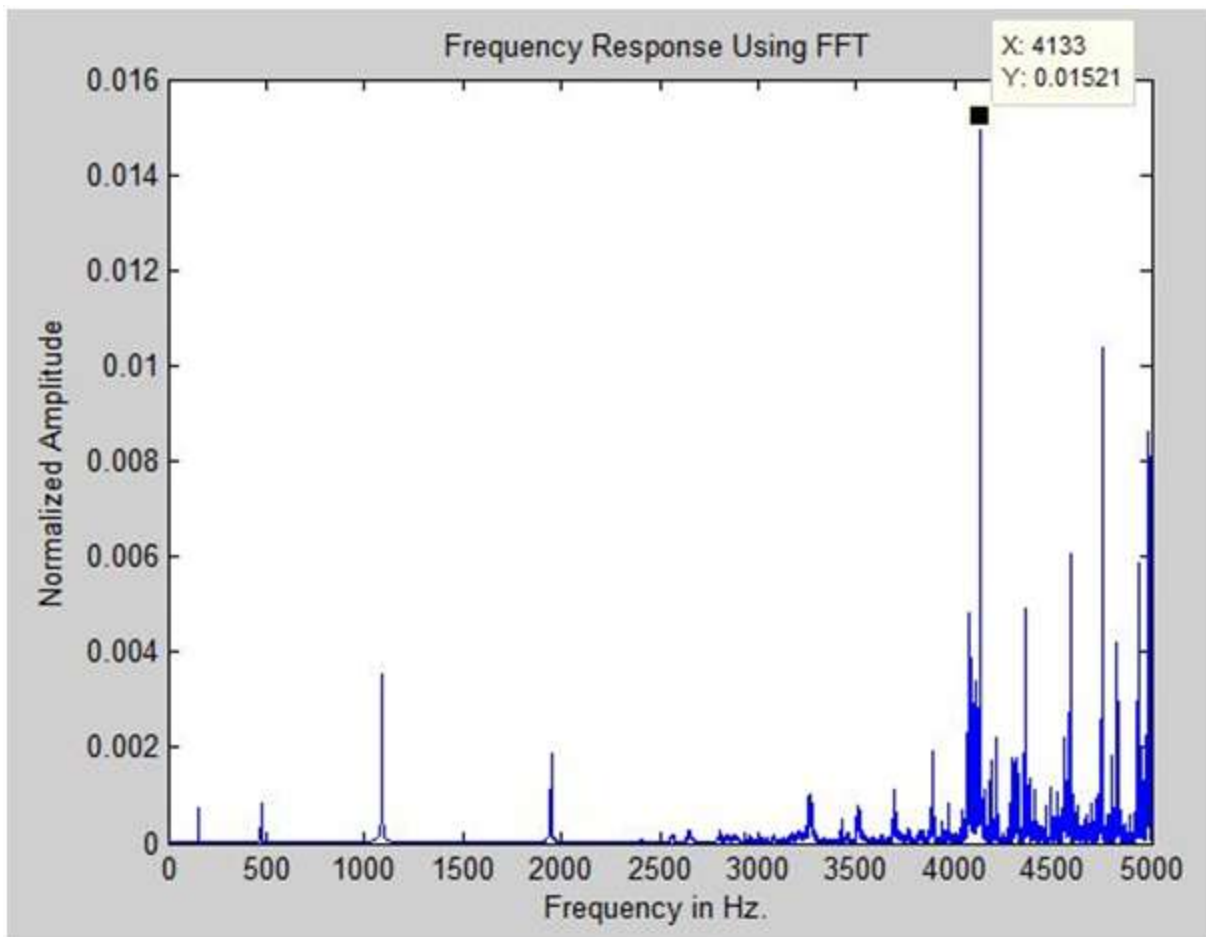
Figure 3. Output plot for bad U-bolt #3, test run #1 showing the natural frequencies after FFT.

For comparison purposes, the natural frequency that had the highest amplitude was recorded at the end of the Matlab code. While this frequency can vary depending on how the bolt is struck by the hammer, in almost every test the same frequency range was produced. This was because of special care taken to strike the bolt in the same place at the same angle each time. This natural frequency was compared between the different bolts to see if there was a noticeable difference for the cracked and un-cracked bolts. The frequency response plot below shows the natural frequencies highlighted from noise. The labeled point is the natural frequency used for comparison. A graph like this was formed for each test and Matlab calculated the precise frequency where resonance occurred.

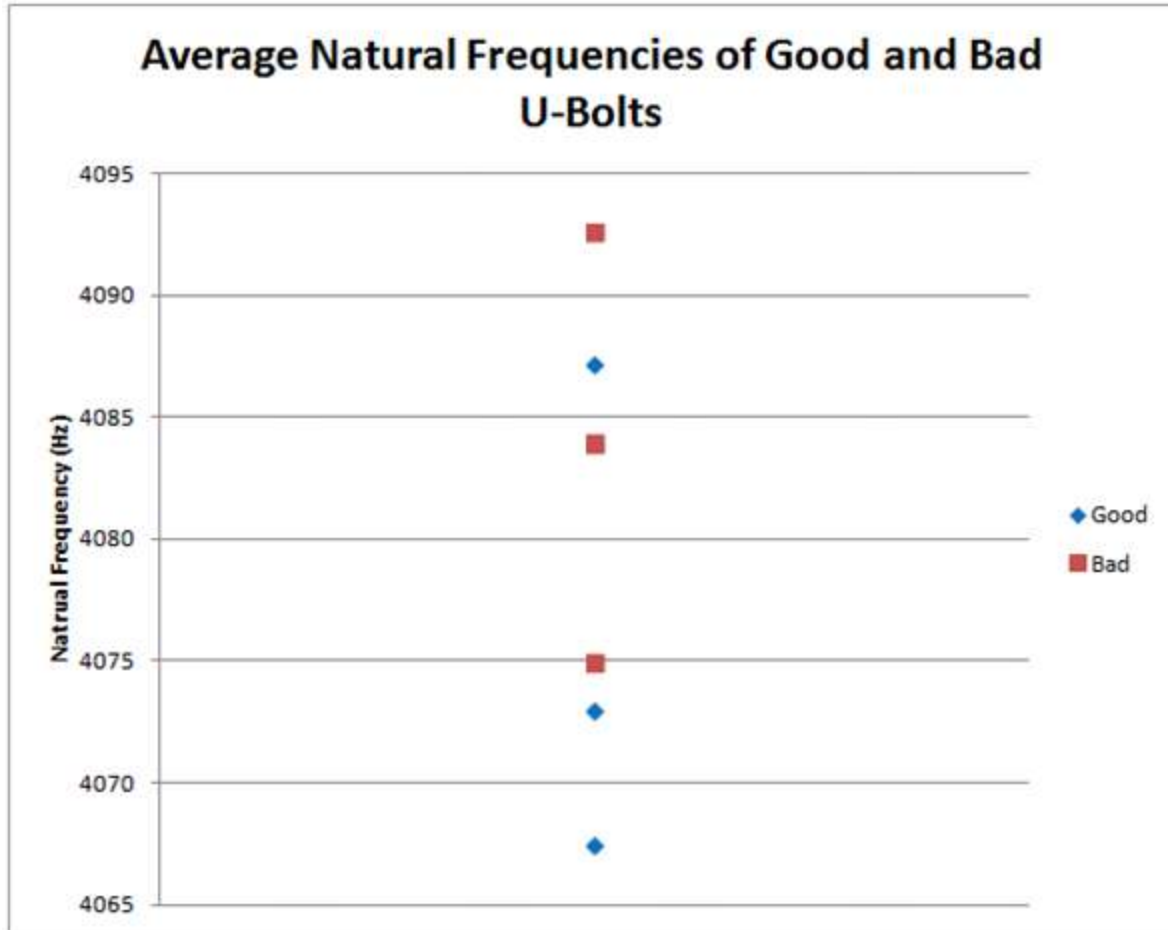
Figure 4. Natural frequency plot from vibration analysis.

From the plot in Fig. 4 and data in Appendix 1, it was clear there was no significant correlation between the natural frequency and whether or not the bolt was cracked. Natural frequency is the square root of the stiffness divided by mass. Ideally, a crack would lower the stiffness of the U-bolt so that the natural frequency would be shifted downward. It appears that the small cracks are not enough to make a noticeable difference compared to other variables.

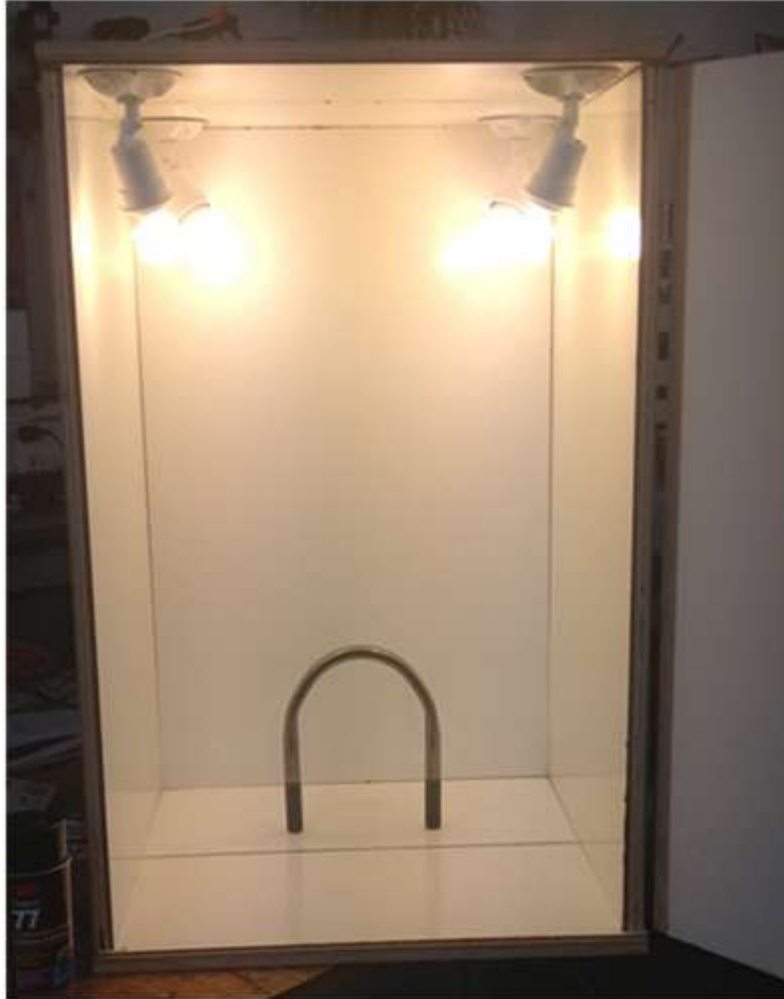
Figure 7. The controlled lighting environment.

The dimensions of the box were created to allow the bolt, as well as any fixture that may be created later to hold the bolt, to fit inside without being too close to a light source which could skew the imaging results. The 2x2x3 ft. box was created of 1/2" thick birch veneer plywood which met the minimal structural requirements while providing a clean appearance. A door was created for access by mounting two standard door hinges to the front face of the box. This could easily be modified to accommodate an automatic opening system such as a pneumatic cylinder. On the inside of the box, a reflective white board was installed to line the inner surfaces of the box to ensure an even light distribution as shown in Fig. 7. At the top of the box are four bright white fluorescent light bulbs which are mounted to freely adjustable fixtures allowing for optimal orientation. Inside the box is an 8 megapixel web camera that is used to take pictures of the U-bolts and export them to a computer. Matlab constantly monitors the folder which the camera saves to [11]. When a new image is detected it automatically runs an analysis by examining a 100x100 sub-matrix of the image pixels and counting the number of pixels that fall under a certain threshold light intensity value. If there is a concentration of dark pixels in one small 100x100 section of the photo, the Matlab code reports the bolt as "bad." This is currently accomplished by running a signal to an Arduino microcontroller commanding it to activate a red light [12]. If it is "good" a green light is activated. In the future, these signals could be used to trigger robots to remove the part from the assembly line to be dealt with later. Both the brightness value for a pixel to be considered "dark" and the number of "dark" pixels in the sub-matrix needed to be considered a crack are adjustable. If a sub-matrix passes the check, the code moves on to the next 100x100 section of pixels in the photo. The Matlab code can be viewed in Appendix 3.

After in depth comparison of these results, the camera inspection system was selected as the best design solution due to the low cost, ease of use, speed and flexibility for use with various parts. After much discussion and observation of the variables that came into play during the data collection for the camera inspection technique, it was concluded that the system would not work consistently without a highly controlled lighting environment. By controlling the lighting environment, the light values inside and outside of the crack should be statistically significant in their differences. To create the controlled lighting environment, a photo-booth-like wooden box was constructed as displayed below.

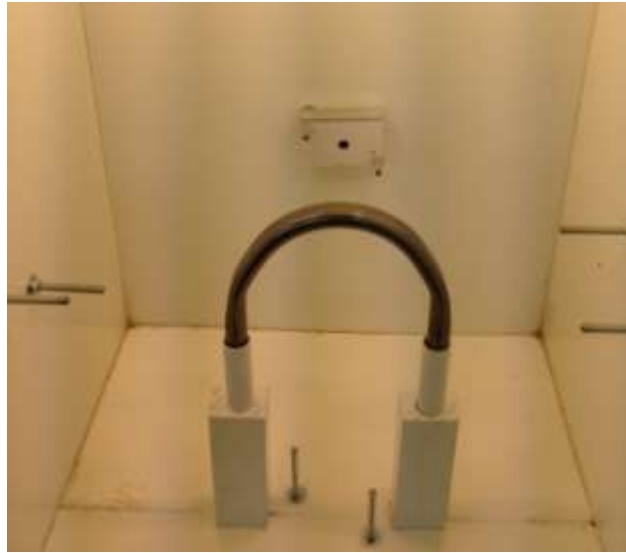
Figure 8. The U-bolt and camera mounts.

After construction of the box, mounting systems were created for the U-bolt and the camera as shown in Fig. 8. The U-bolt simply slides into tubes which hold it upright. The white tubes were made from scrap PVC pipe and 2x4" lumber, painted white so it would not have any dark spots which could interfere with the scanning accuracy. The camera mount was made by inserting the web camera into a plastic shell. The shell then slides onto bolts protruding from the walls. The camera itself is simply an 8 megapixel web camera made by Logitech. 8 megapixels was chosen because in the initial testing, 8 MP cameras provided sufficient resolution to depict even small cracks.
